Dimming T8 fluorescent system problems

In the field with Lighting Diagnostics...

Solving a lighting mystery at a big box retail store

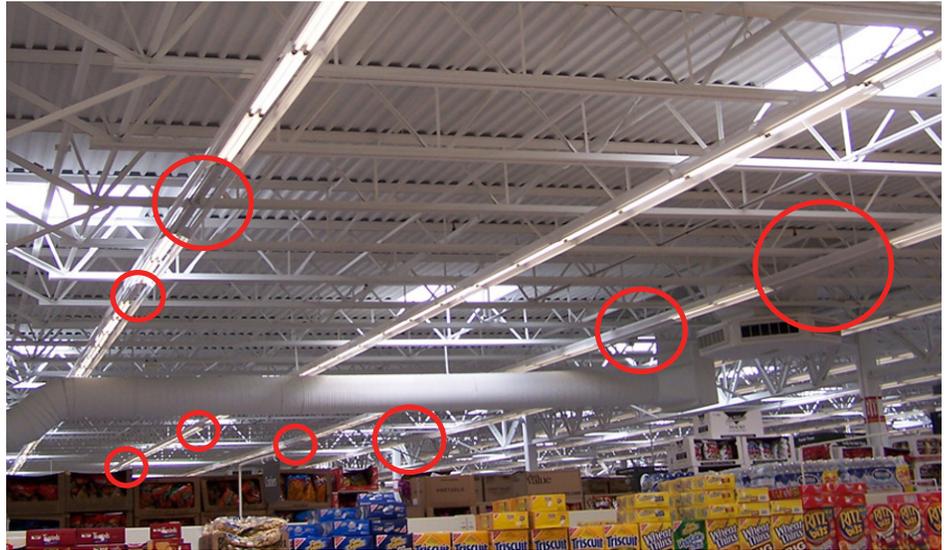
Some of the problems identified by Lighting Diagnostics investigators are circled above.

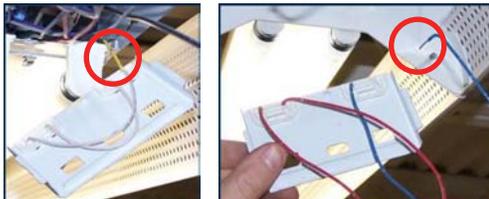
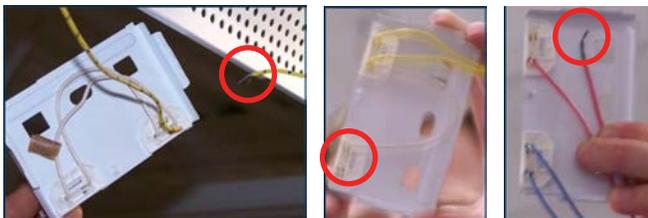
- Lighting Diagnostics investigators found a number of luminaires wired incorrectly.
- Expect open electrodes in all cases of incorrect wiring.
- The most likely cause of lamp failure is improper luminaire wiring or lamp installation. Both prevent electrode heating—crucial while dimming.
- Luminaire covers were in contact with lamps and created phosphor burns on the lamps. Lamps are sensitive to direct contact with grounded housings.
- Luminaire cover tabs were not installed correctly.
- Connectors were unplugged.
- Power wires were not connected.

Examples of wires not connected in luminaires

Tug on each ballast wire connected to the lamp holder to make sure the wires are installed correctly. If a wire is not connected securely, the lamp may operate, but electrode heating will not be applied.
