## Dimming T8 fluorescent system problems

## Solving a lighting mystery at a big box retail store

The *Lighting Diagnostics* team at NLRIP examined the lighting system in a big box retail store in the Albany, New York area to learn why fluorescent lamps used in a dimming system were experiencing shortened life. The system of 1350 luminaires (fixtures) and dimming ballasts had been installed as an energy-saving alternative.

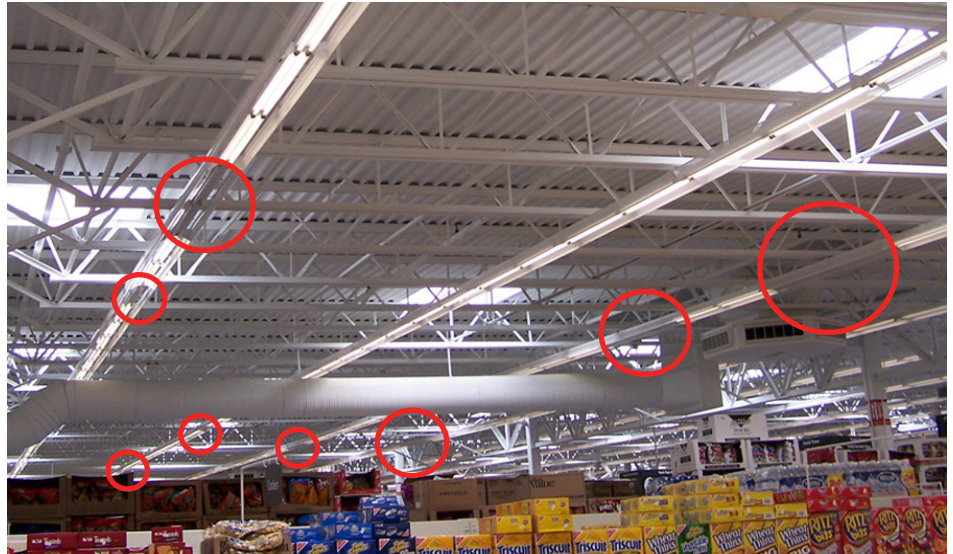
Some of the problems identified by Lighting Diagnostics investigators are circled above.

- 44% had lamps with open electrodes. Not all of these lamps showed end darkening.
- 41% had ballast failures. These ballasts were cold to the touch, indicating they were not energized. Voltage was verified at the input to all ballasts and rechecked after turning the power off and on.
- 21% had luminaire anomalies such as wires not connected or wires connected improperly.
- 15% had installation anomalies such as lamps not inserted properly or rotated into holders, lack of continuity in electrode heating circuit, or luminaire covers not installed properly.

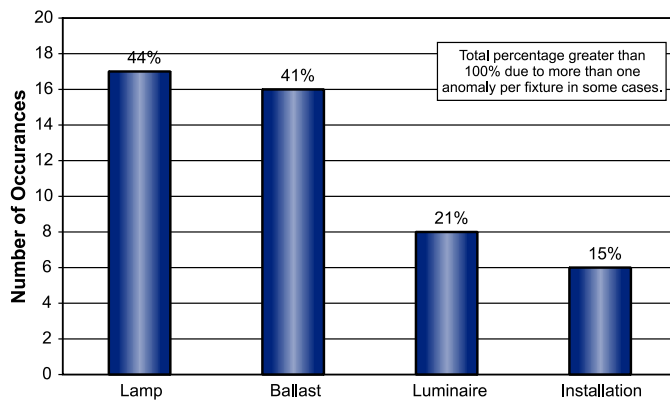
Types of problems found

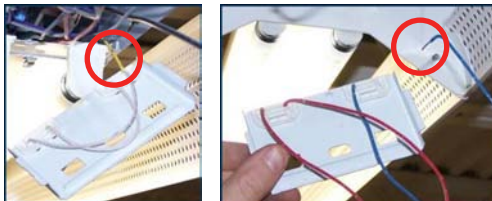
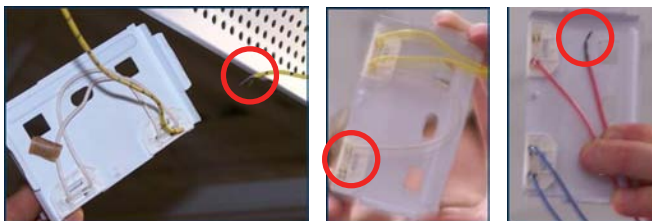
- Lighting Diagnostics investigators found a number of luminaires wired incorrectly.
- Expect open electrodes in all cases of incorrect wiring.
- The most likely cause of lamp failure is improper luminaire wiring or lamp installation. Both prevent electrode heating—crucial while dimming.
- Luminaire covers were in contact with lamps and created phosphor burns on the lamps. Lamps are sensitive to direct contact with grounded housings.
- Luminaire cover tabs were not installed correctly.
- Connectors were unplugged.
- Power wires were not connected.

Examples of wires not connected in luminaires
