**RESULTS REPORT:**  
**FACILITY LIGHTING — SUMMER**

WAYNE N. ASPINALL FEDERAL BUILDING  
GRAND JUNCTION, COLORADO

Lighting Research Center  
Rensselaer Polytechnic Institute

SUBMITTED AUGUST 11, 2014

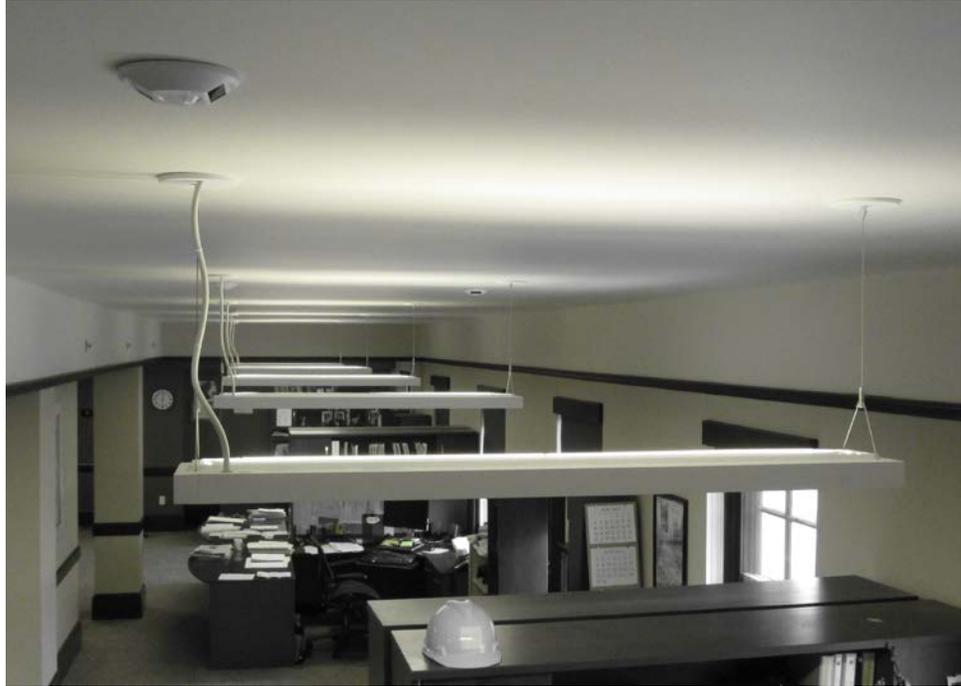
As shown in Figure 2, linear fluorescent luminaires were specified in open-plan offices. The target illuminance on the work plane in open offices was 30 footcandles (fc), or approximately 300 lux (lx).<sup>3</sup> With task lighting, target illuminance was 50 fc (500 lx).

**Figure 2. Linear fluorescent pendants provide the general lighting in open-plan offices. Wireless sensors (upper left) help to reduce energy use by dimming the lights in response to daylight and switching them off when the offices are vacant.**

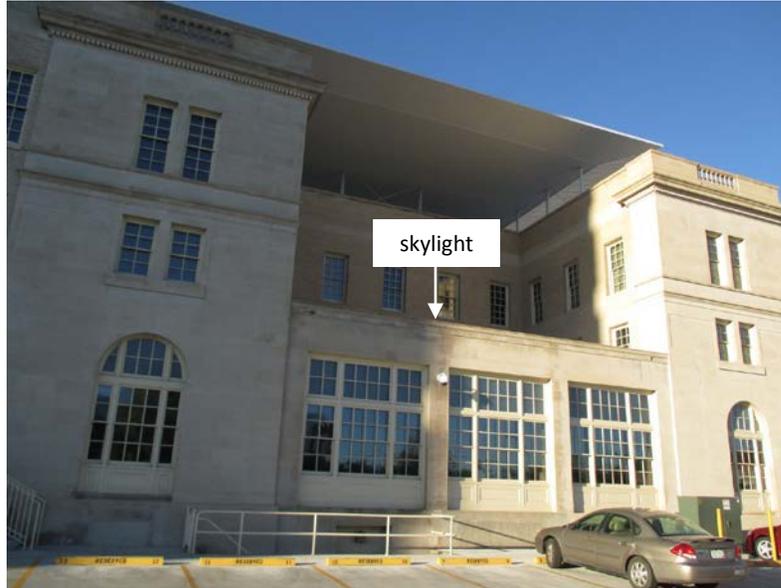
*Figure 4. On early summer mornings, some direct sun falls on the north side of the building. The skylight on the first floor is well-shaded on this north side of building.*

The Aspinall building is surrounded by other low- and medium-height office buildings. On early summer mornings, the sun briefly falls on the north side of the building (Figure 4). Daylight is admitted primarily through window openings punched through the historic masonry. Historic windows have a new storm window layer with tinted film (45% visible transmittance, 0.53 solar heat gain coefficient). The skylight on the first floor was also tinted (60% visible transmittance, 0.49 solar heat gain coefficient), and shaded by the building itself (Figure 4). Black mesh shades are provided for most windows. Windows on the south façade are also provided with blackout shades.

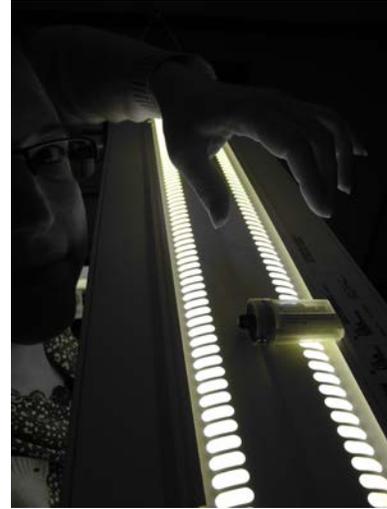
Three battery-powered light meters were placed on top of operating luminaires to verify whether the lights were dimming in response to daylight (Figure 13). The devices were placed on luminaires located in the same control zone as the desks where illuminance measurements took place: on the north and west sides of the first floor, and the south side of the second floor. These were the same luminaires that were monitored in January 2014.

**Figure 13.** An LRC researcher installs a battery-powered light meter in a luminaire.

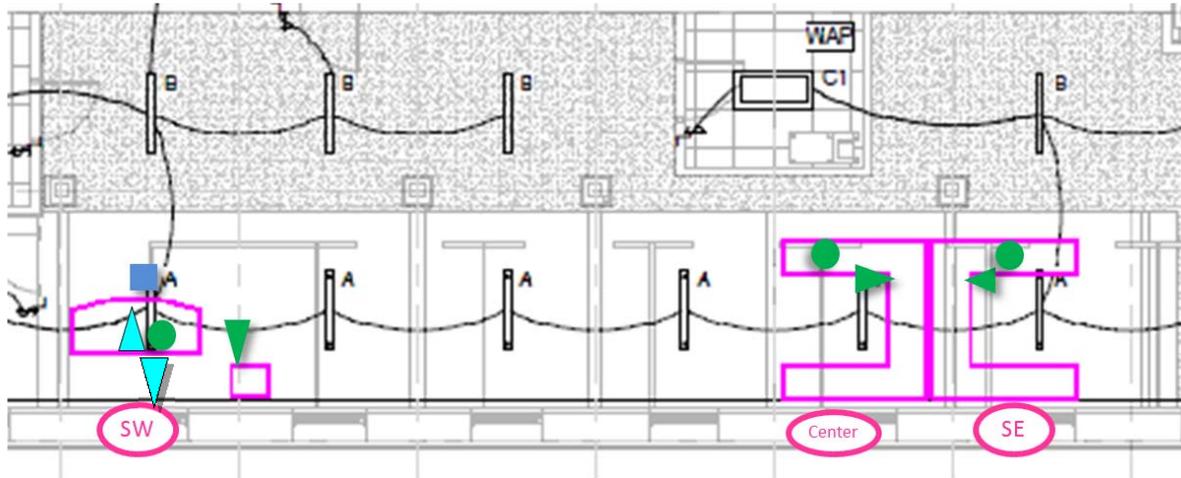
Spectral power distribution (SPD) was measured at 3 desks on the 2<sup>nd</sup> floor. These were the same desks where illuminance and luminance were measured (Appendix A). SPDs were measured repeatedly over the day.

*Desks on the second floor where SPD measurements were collected*
