Dimming T8 fluorescent system problems

In the field with Lighting Diagnostics...

Solving a lighting mystery at a big box retail store

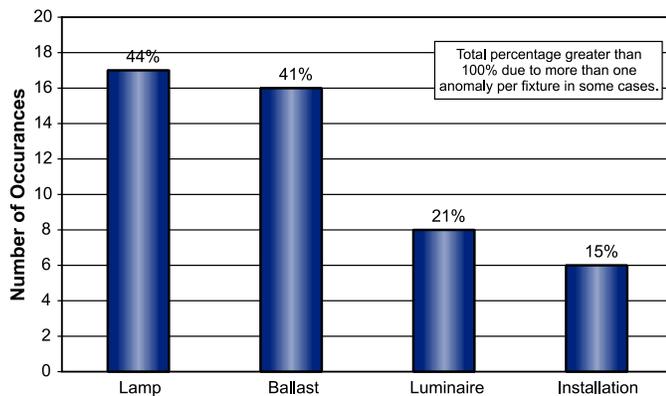
- Problems appeared to be randomly distributed throughout the store.
- 10% of the luminaires contained lamps that had either failed or were inoperative.
- 7% of the lamps had failed or were inoperative.

- 44% had lamps with open electrodes. Not all of these lamps showed end darkening.
- 41% had ballast failures. These ballasts were cold to the touch, indicating they were not energized. Voltage was verified at the input to all ballasts and rechecked after turning the power off and on.
- 21% had luminaire anomalies such as wires not connected or wires connected improperly.
- 15% had installation anomalies such as lamps not inserted properly or rotated into holders, lack of continuity in electrode heating circuit, or luminaire covers not installed properly.
