Evaluation of Fabrication Errors on the Performance of Injection Molded Light Pipes (Waveguides)

John Van Derlofske

Transportation Lighting Group, Lighting Research Center, Rensselaer Polytechnic Institute

Reprinted From: **Lighting Technology Developments for Automobiles
(SP-1595)**

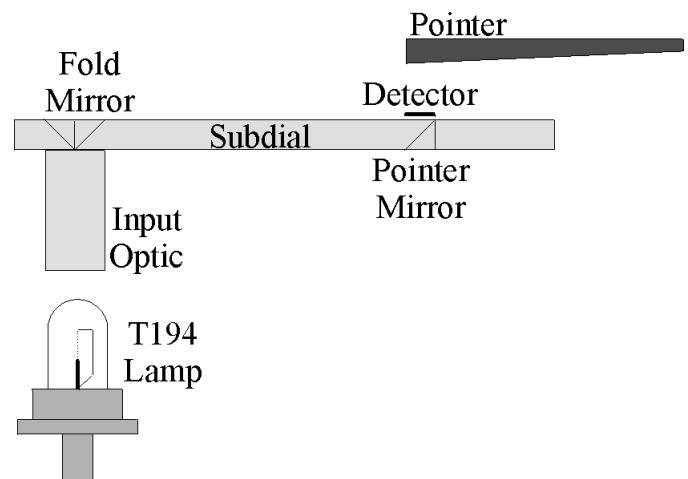
Figure 2 shows the right half of a cross-sectional view of the pointer light pipe system. This system is designed to illuminate two pointers from one lamp. However, since this system is symmetric about the lamp only one side is considered. It consists of: a T194 lamp source, a collection optic, a fold mirror, a slab subdial light pipe, pointer mirrors, and pointers.

Light is collected from the lamp and bent 90° by the fold mirror into the subdial. The light propagates in two directions through the slab light pipe until it encounters a pointer mirror. It is then bent another 90° out of the subdial and is incident on a pointer. The pointer output couples the light to the viewer. The detector plane shown in Figure 2 is not in the actual system but is used for modeling purposes.

Figure 2. Instrument cluster pointer light pipe illumination system.

The system was computer modeled in three-dimensions with the geometry shown in figure 2. The plastic material used was polycarbonate (index $n=1.59$). The dimensions of the physical system were reproduced as accurately as possible. The geometry and optical properties of the lamp were modeled to closely approximate the measured lamp output.[4] A detector plane was placed above the pointer mirror to collect the pointer mirror output flux.

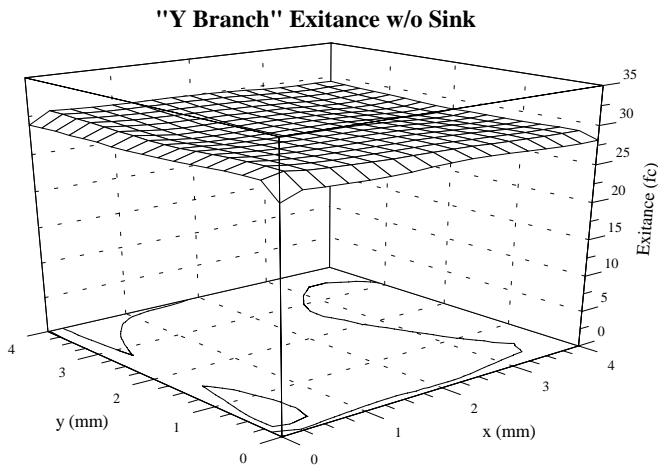
Figure 10 shows the measured exitance distribution for the clear control Y branch light pipe and figure 11 shows the exitance distribution for the Y branch light pipe with the sink.

Figure 10. Y branch light pipe exitance distribution.

As seen in the straight waveguide case the two distributions are very similar. Both have a uniform output distribution with only a slight roll off at the edges due to fiber sampling. The only major difference between the two distributions is the overall output level. The control light pipe has an average exitance of 28.7fc and the void include light pipe has an average exitance of 19.5fc. This is a decrease in output of ~32%.
