Demonstration and Evaluation of Lighting Technologies and Applications • Lighting Research Center

Lighting Case Studies

Volume 2, Issue 4

South Mall Towers Apartments
Albany, New York

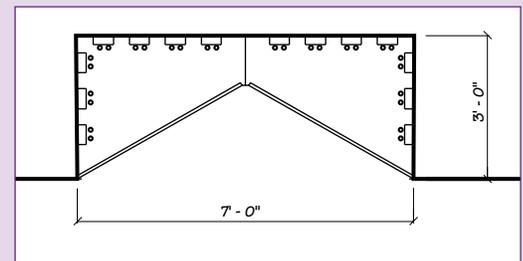
Section through electric skylight

Seniors are more likely than younger people to be partially sighted and to suffer from shallow, fragmented sleep. Exposure to bright light can help overcome the effects of some forms of partial sight and can improve the quality of sleep. The challenge for the lighting designer is to provide bright light exposure without visual discomfort. At South Mall Towers, this problem was solved by providing an electric skylight in the mail area open to the community room. The light output of the skylight is variable, the maximum illuminance at the eye being 300 fc (3200 lx). The large acrylic prismatic panels minimize glare. The residents' initial response to this light therapy area has been positive.

CD Simulated skylight with T8 fluorescent lamp striplights, dimming ballasts, and prismatic lenses. Skylight (see page 3) used for experimental light therapy. (Results not addressed in this publication.)

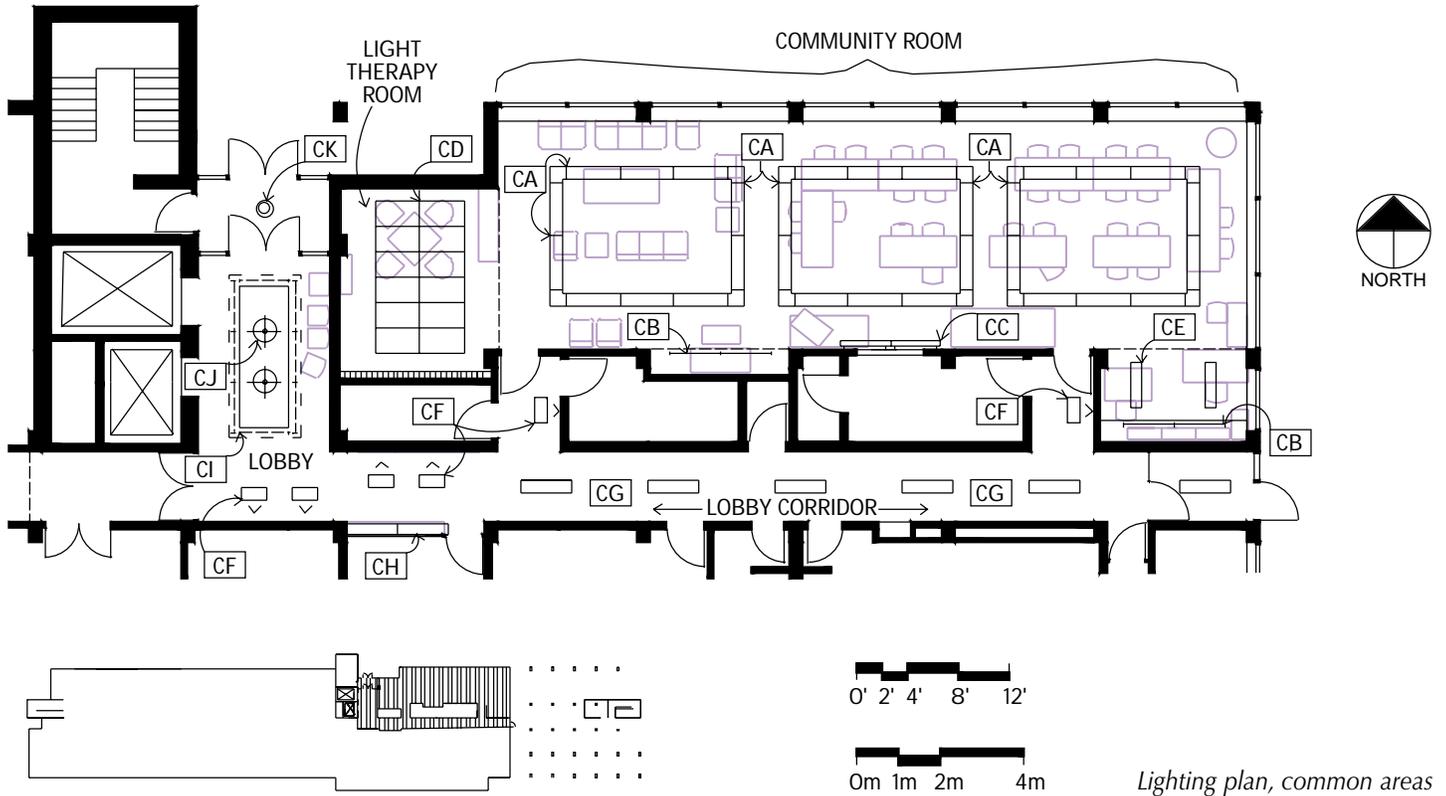
Lighting plan, common areas

CA Pendant-mounted up/downlight (60% up; 40% down), two fluorescent lamps in cross section. Rounded extruded aluminum housing, 3.5" x 12" (89 x 310 mm), assembled in rectangular configurations. Electronic dimming ballasts. Downward aperture uses white-painted aluminum baffles, 1.5" (38 mm) high by 3" (76 mm) on center. Lamps: (2) F32T8/735 per 4' (1220 mm) length.

CB Ceiling-mounted striplight, 8' (2440 mm) long, one fluorescent lamp in cross section. Striplight concealed behind job-built wood fascia. Electronic dimming ballasts. Lamps: (2) F32T8/735

CC Wall-mounted downlight luminaire, 6" x 6" x 8' long (150 mm x 150 mm x 2440 mm), one fluorescent lamp in cross section. Downlight aperture has 3/4" high x 3/4" on center (18 mm x 18 mm) white-painted aluminum baffles. Lamps: (2) F32T8/735

CE Surface-mounted downlight, 6" x 4' (150 mm x 1220 mm), two fluorescent lamps in cross section. White-painted baffles 1" high x 1" on center (25 mm x 25 mm). Lamps: (2) F32T8/735

CF Recessed linear wall washer, 8" x 2' (200 mm x 1220 mm), one CFL in cross section. White-painted 1" (75 mm) high baffles. Lamp: FT40W/2G11/RS/835

CG Recessed luminaire, 1' x 4' (300 mm x 1220 mm), two fluorescent lamps in cross section, with white-painted 3" (76 mm) high parabolic baffles. Wide light distribution perpendicular to lamps; narrow, lengthwise. Lamps: (2) F32T8/735

CH Recessed downlight, 8" x 4' (200 mm x 1220 mm), two fluorescent lamps in cross section, with 3" high white-painted parabolic baffles. Lamps: (2) F32T8/735

CI Striplight, 8' (2440 mm) or 4' (1220 mm) long, one fluorescent lamp in cross section, mounted as upright in lobby cove. Electronic dimming ballast. Lamp: F32T8/735

CJ Pendant-mounted CFL luminaire, with decorative translucent acrylic bowl, 22" (560 mm) in diameter. Lamps: (4) FT18W/2G11/RS/835

CK Ceiling-mounted semi-direct luminaire, two CFLs in cross section. White-painted egg-crate louver in downlight aperture with 1/2" x 1/2" x 1/2" (12 mm x 12 mm x 12 mm) cells. Lamps: (2) CFQ26W/G24q/835

CL Surface-mounted "stacklight" luminaire, one fluorescent lamp in cross section, with U-shaped white-painted aluminum baffles spaced 1" (25 mm) apart. Electronic dimming ballast. Lamp: F32T8/735

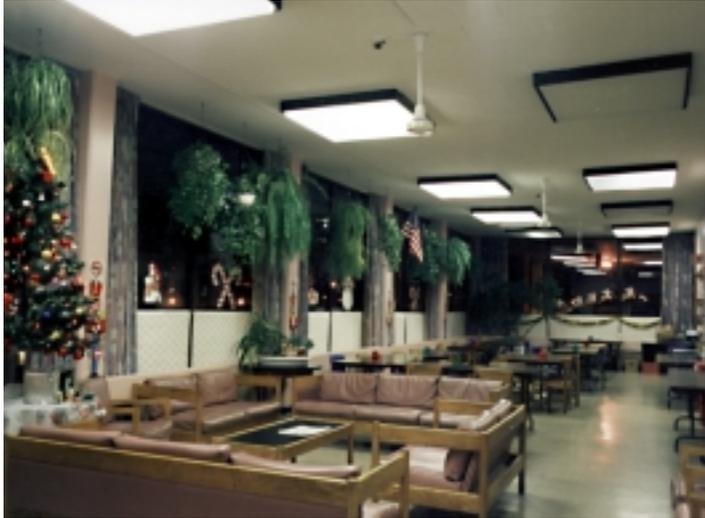
Community room showing previous lighting

Previous conditions The original lighting of the community room consisted of ten 4' x 4' (1.2 m x 1.2 m) ceiling-mounted opal diffuser luminaires, each using six 34-W T12 CW fluorescent lamps and three RS electronic ballasts. The small office area and mailbox area off the community room were primarily lighted with

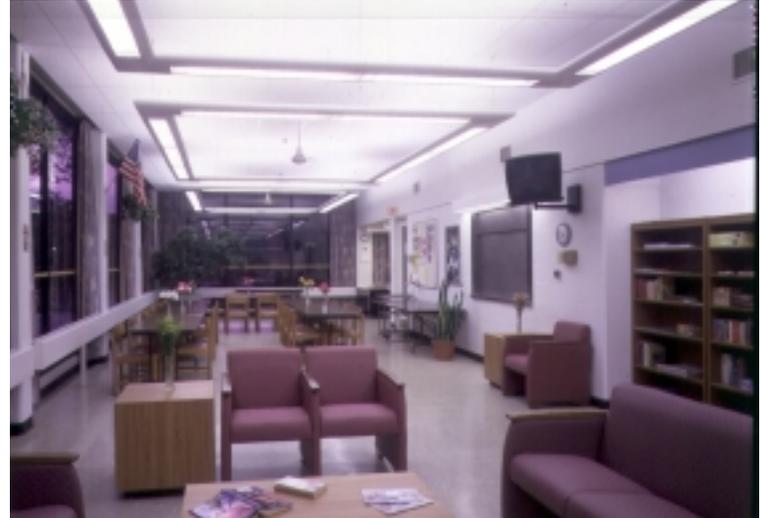
Community room showing new lighting (type CA)

New conditions The old acoustical ceiling in the Community Room was replaced during the

ent light. The new electric lighting alone produces 51 to 110 fc (550 to 1200 lx) of ambient light, easily exceeding illuminances recommended in the Illuminating Engineering Society of North America's Recommended Practice 28, "Lighting and the Visual Environment for Senior Living" (see *Evaluation*).

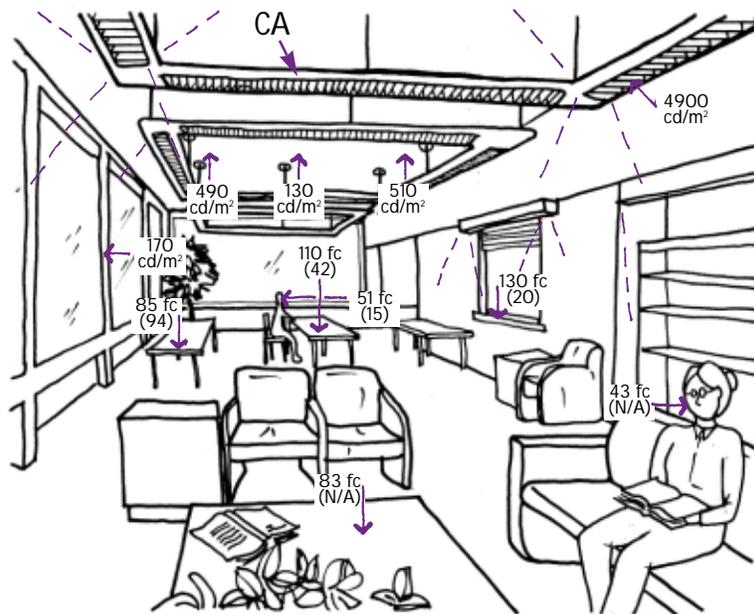
Perspective of community room. (The values for the new lighting are for electric lighting only. Previous values shown in parentheses include both electric lighting and daylight.)

During a sunny day in May, the combinations of daylight and the old electric lighting system produced illuminances on the food and coffee tables ranging from 20 to 110 footcandles (fc) [210 to 1100 lux (lx)], the higher illuminances being measured close to the windows. By itself, the previous electric lighting system delivered an average of only 19 fc (200 lx) of ambi-

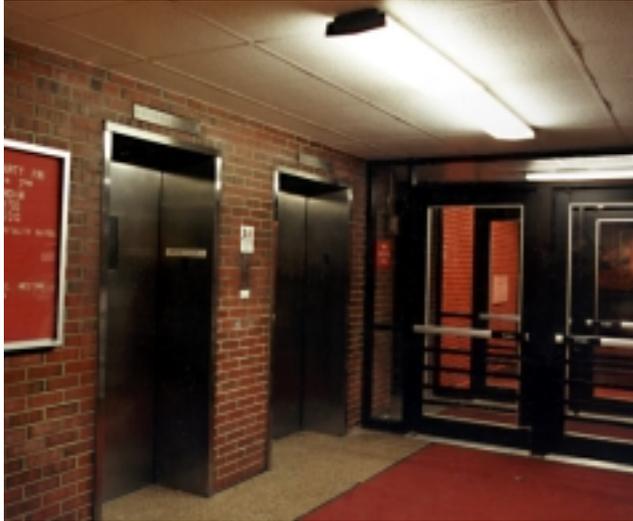
Lobby showing previous lighting

Previous conditions The lobby's previous lighting consisted of two 4' (1.2 m) long, ceiling-mounted fluorescent luminaires with prismatic wraparound lenses. A third such

luminaire was used to light the vestibule. Each two-lamp luminaire used 34-W T12 CW fluorescent lamps on an electronic ballast. The photomural was lit with two eyeball-type luminaires, each luminaire containing one 65-W incandescent floodlight, but was uneven. In daytime, daylight reaches the lobby through the glass doors, making it appear bright and evenly lit. After dark, however, the lobby lighting was seen as uneven and glaring. Because seniors' eyes take longer to adapt to a change in brightness, the difference in brightness between the lobby and the outdoors made it difficult for residents to see clearly immediately after leaving the building.

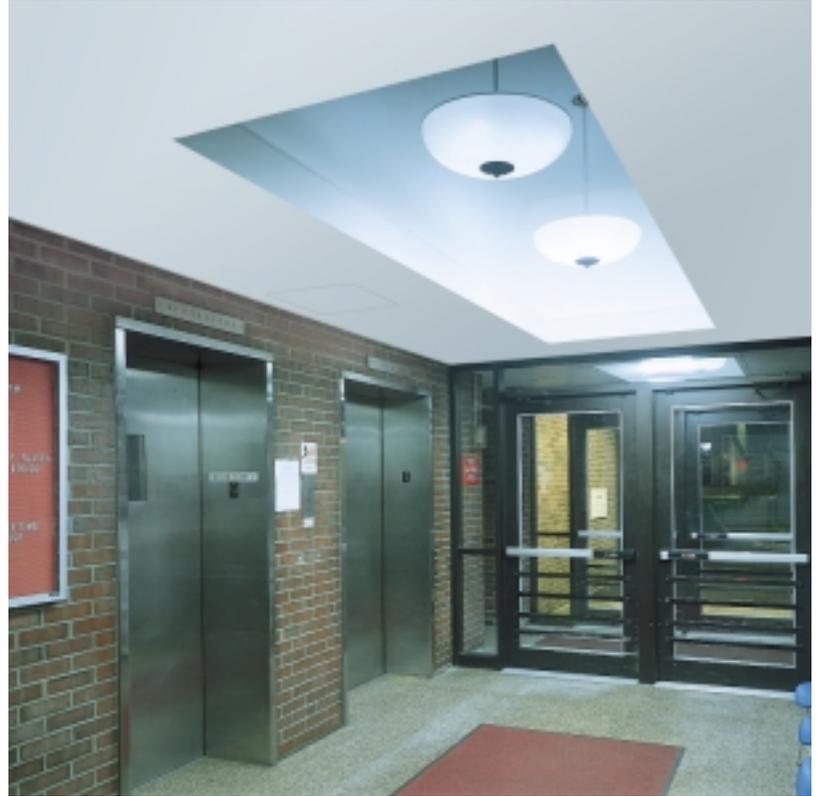
Lobby showing new lighting (types CI and CJ)

New conditions In 1998, the lobby lighting was replaced with cove lighting (type CI), pendants (type CJ), and recessed wall washers (type CF). The apparent size of the lobby has been increased by opening up the plenum to install a 2'-6" (0.76 m) high coffer containing two pendants for decorative effect. Glare has been reduced because the whole coffer acts as a large area light source. The cove lighting is automatically dimmed to 8% of full light output at night by a time clock, reducing the brightness difference between lobby and outdoors. The photomural is now lighted by using two recessed CFL wall-washing luminaires (type CF) centered 28" (710 mm) from the wall.

South Mall Towers has experienced only one major problem with product performance since the new lighting was installed. The lamps installed in the pendant luminaires (type CJ) in the lobby failed after fewer than a thousand hours. These lamps were returned to the manufacturer, who declared them to be part of a defective batch and supplied replacements. The replacement lamps have been operating satisfactorily for approximately one year.

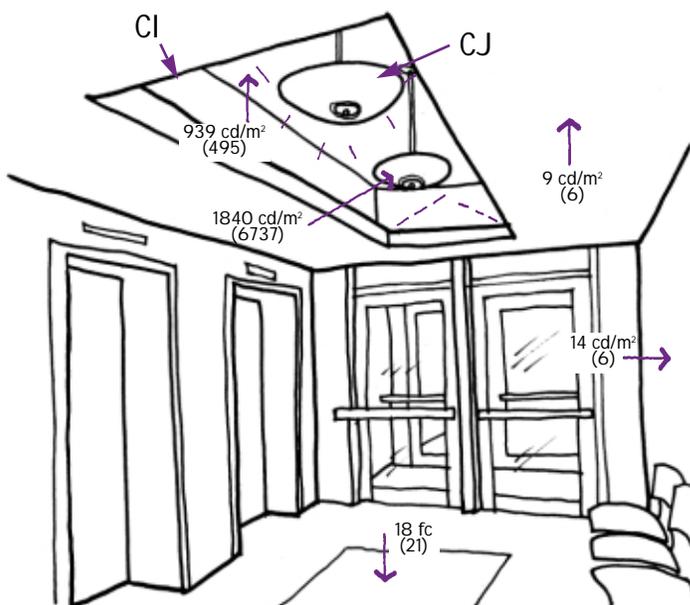
Perspective of lobby, night (previous values shown in parentheses)

After dark, with the cove lighting dimmed, illuminances on the floor of the lobby are very similar to previous values, but the brightness of the cove is considerably less than that of the previous luminaire (see values on illustration on page 7). As for the photomural wall, illuminances are much higher than before, but the illuminance distribution is still uneven, particularly at the top of the wall (visible in lobby corridor photos and drawing on page 9).

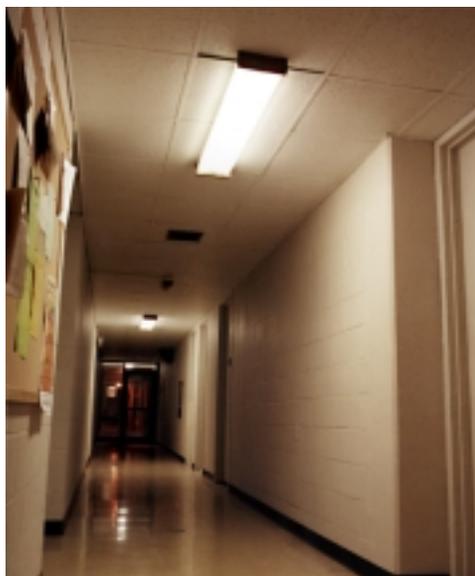
Lobby corridor, showing previous lighting

night. The previous lighting of the corridor consisted of three 4' (1.2 m) long fluorescent lamp wraparound luminaires, two luminaires along the corridor and one in the small entry lobby. The two short corridors giving access to the community room were not lighted. Both day and night, the corridor appeared dim, and the light was unevenly distributed. Points of interest received only incidental light from the corridor lighting.

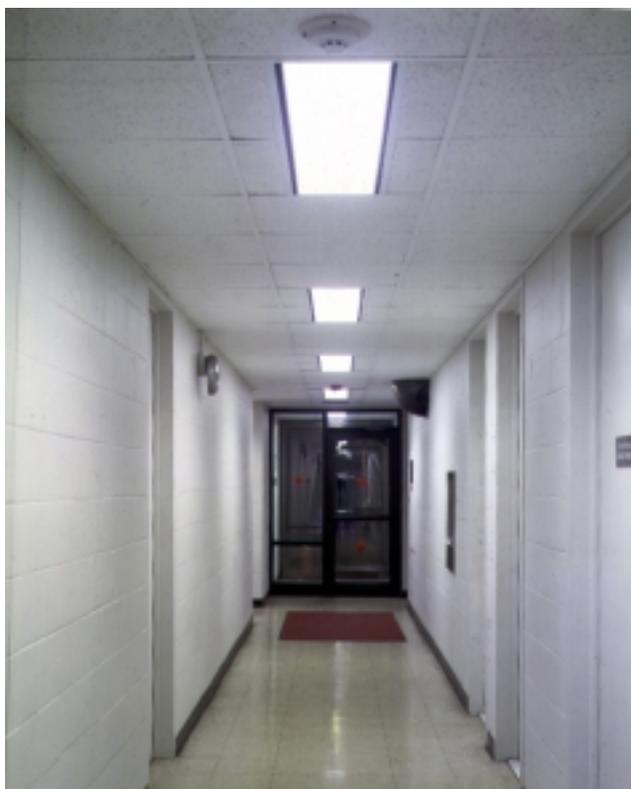
Lobby corridor, showing new lighting (type CG)

corridor now is lighted with six recessed 1' x 4' (0.3 x 1.2 m) recessed, baffled luminaires (type CG), spaced 10' (3 m) on center. Additional 2' (0.6 m) wall-washing luminaires (type CF) are installed in each of the short corridors leading to the community room and adjacent to the bulletin board. Task lighting over the main administrative office counter is provided by two recessed 9" x 4' (230 x 1200 mm) fluorescent luminaires (type CH) with baffles.

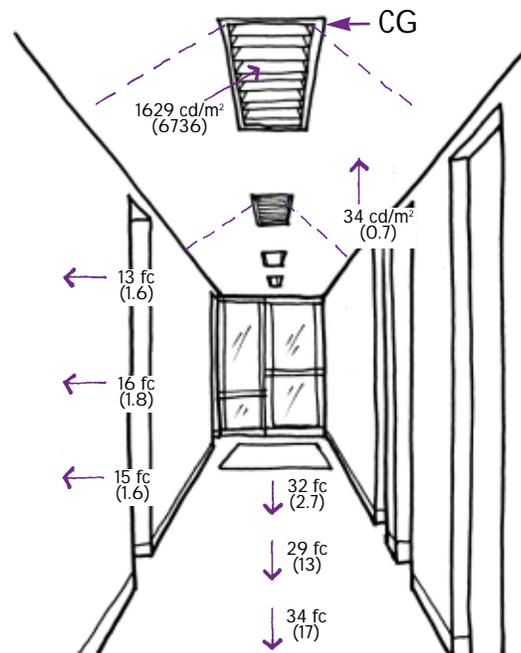
Perspective of lobby corridor (previous values shown in parentheses)

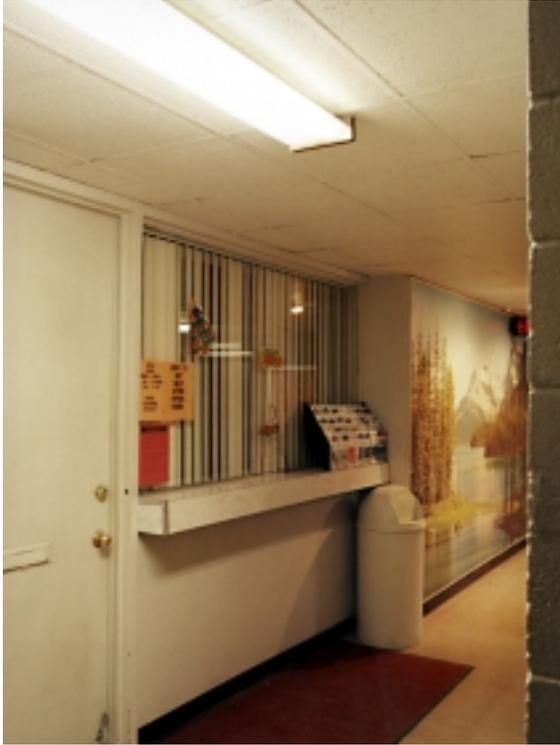
Administrative office counter in lobby corridor, showing previous lighting

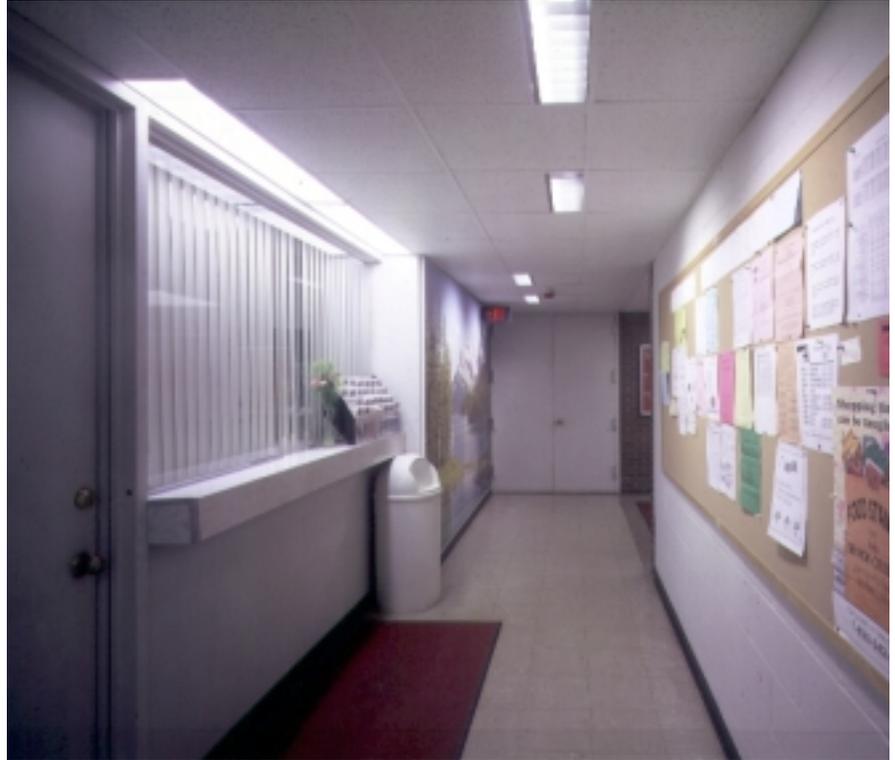
Administrative office counter in lobby corridor, showing new lighting (type CH)

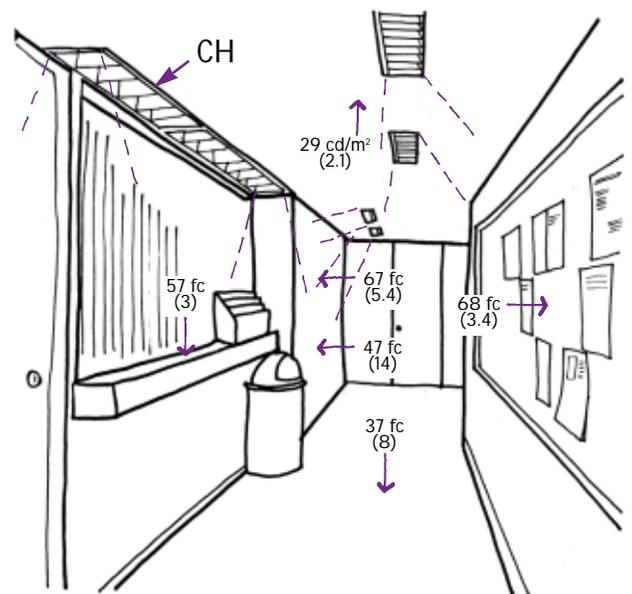
Perspective of administrative office counter in lobby corridor (previous values shown in parentheses)

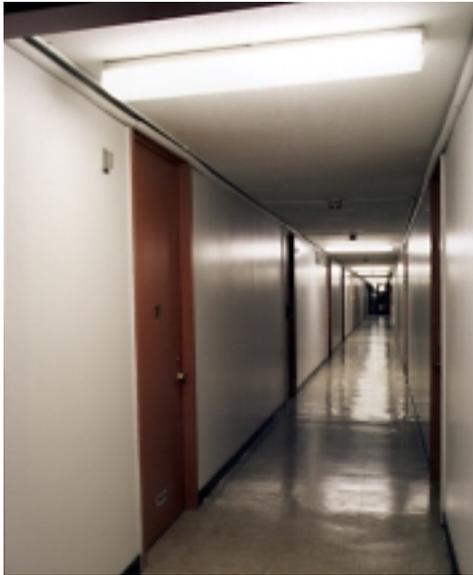
Residential corridor, showing previous lighting

Previous conditions The residential corridor was lighted 24 hours a day by 4' (1.2 m) ceiling-mounted luminaires with wraparound opal diffusers, spaced 16' to 30' (4.9 to 9.1 m) on center, oriented cross-wise to the corridor. Daylight from the end of the corridor contributed little to its illuminance, but the windows or doors were a disturbing source of glare during the day. After

dark, the previous lighting was seen as glaring and uneven.

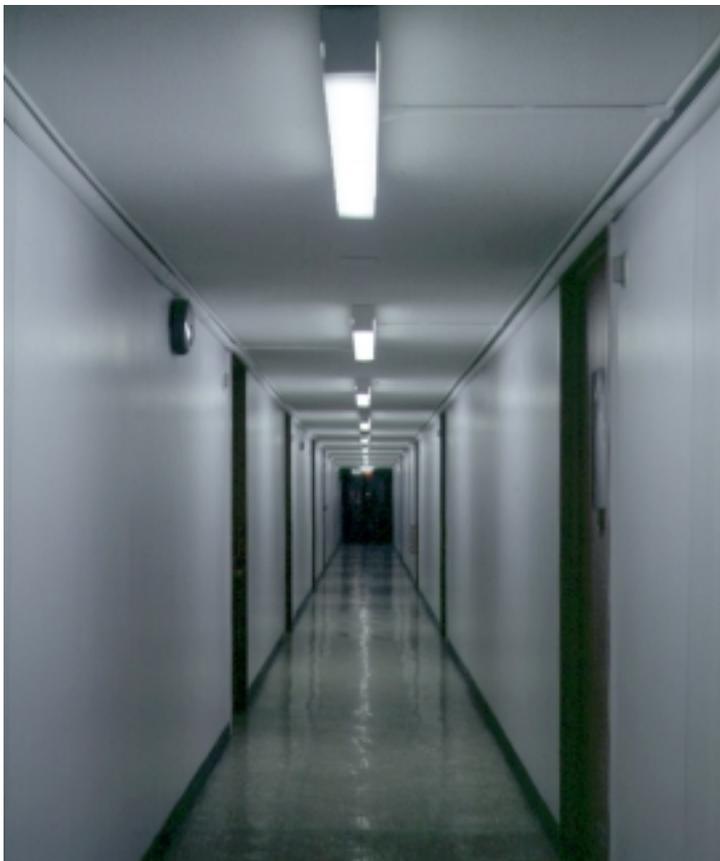
Residential corridor, showing new lighting (type CL)

New conditions Because the ceiling is concrete, the newly installed lighting system was limited to surface-mounted luminaires and wiring. “Stacklight” luminaires (type CL) are spaced 12’ (3.6 m) on center parallel to the length of the corridor. These luminaires spread light on the side walls, but U-shaped white baffles block the direct view of the lamp as residents travel the corridor. Round ceiling-mounted luminaires (type CK) are used to distinguish elevator and entry lobbies, as well as turning points in the corridors. These CFL units have opaque sides but feature upward spill light and louvered downlight to reduce direct glare and the relative brightness of the luminaire against the ceiling.

To save energy, the stacklight luminaires are connected to three occupancy sensors. When any one of the occupancy sensors detects someone entering the corridor, all the luminaires are turned to full light output. They stay in this condition until 20 seconds after the space becomes vacant, then revert to 8% of full light output. For safety reasons, the luminaires are never fully switched off.

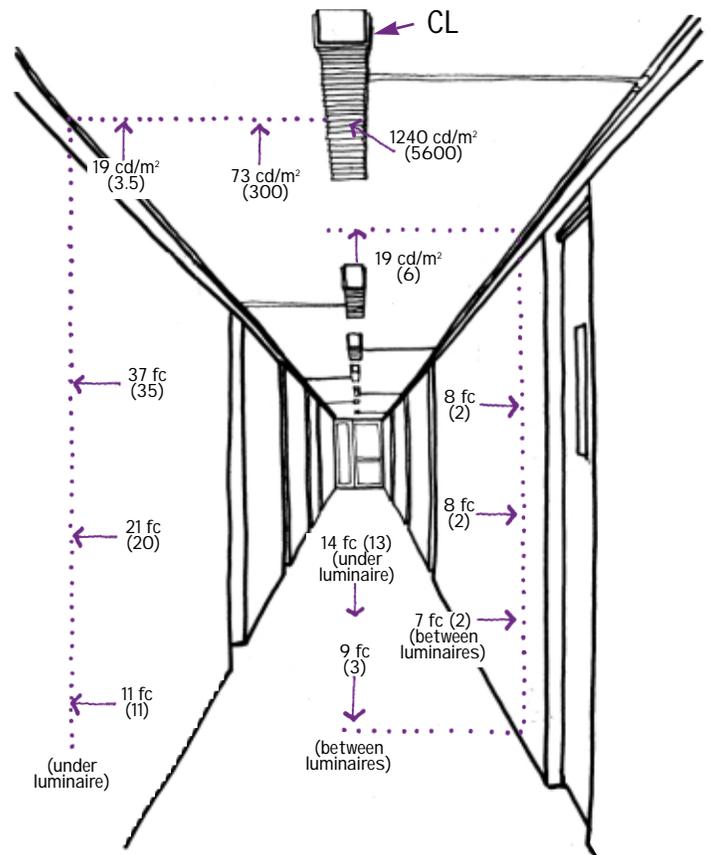
Perspective of residential corridor, new lighting (previous values shown in parentheses)

At full output, the new lighting in the corridor provides higher illuminances on the floor of the corridor than the previous lighting (see ranges on illustration above). Horizontal illuminances are more uniform (new average/minimum = 1.09 ; previous average/minimum = 2.78). Luminaire brightness is also lower, reducing glare from the electric lighting, but the daylight glare is still a problem.

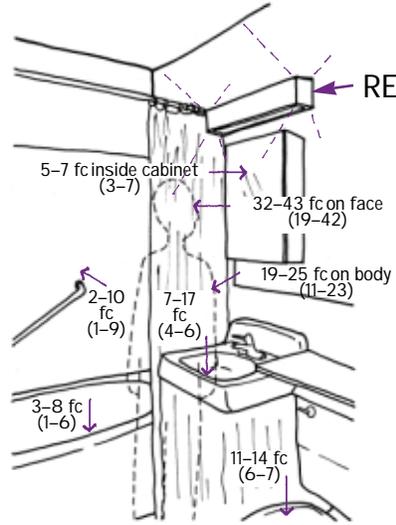
Perspective of bathroom, new lighting conditions (previous values shown in parentheses)

New conditions The retrofitted luminaires are also mounted over the mirror, but both types RE and RE' have an opaque panel facing the viewer. This panel blocks much of the direct glare and sends more light upward to produce diffuse indirect light on the face and body. These luminaires distribute light more

widely around the bathroom, increasing illuminance on the body, sink, and elsewhere in the bathroom (see ranges on illustrations above and at right).

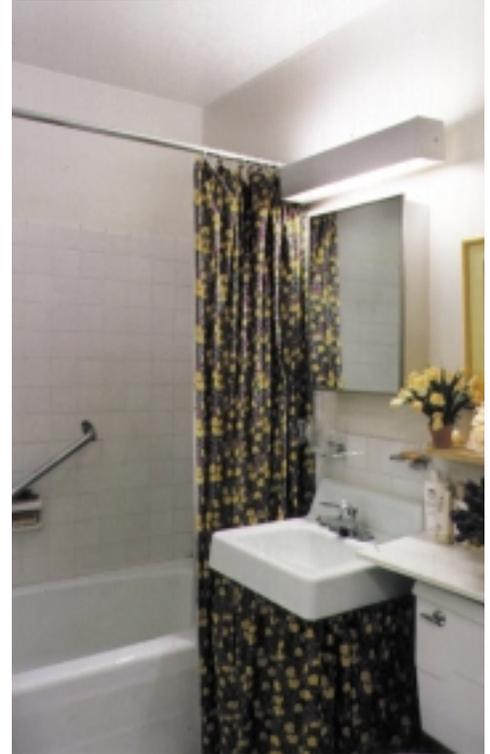
Bathroom, showing new lighting (type RE)

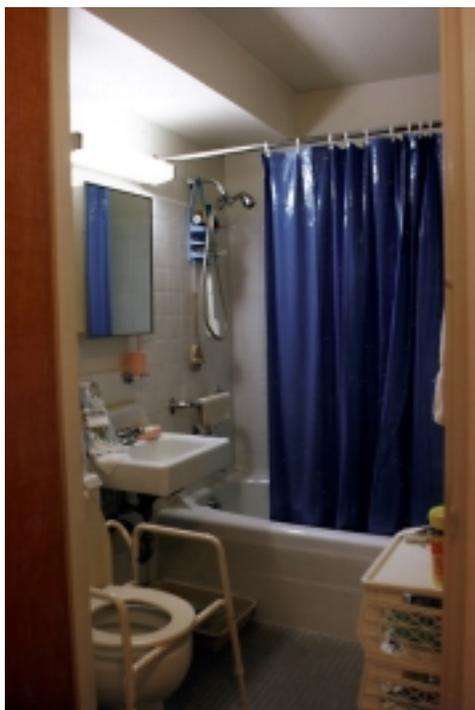
Bathroom, showing previous lighting

Previous conditions The previous fluorescent lamp luminaire was mounted above the mirror over the sink. Illuminances elsewhere in the bathroom were low (see ranges on illustrations at right).

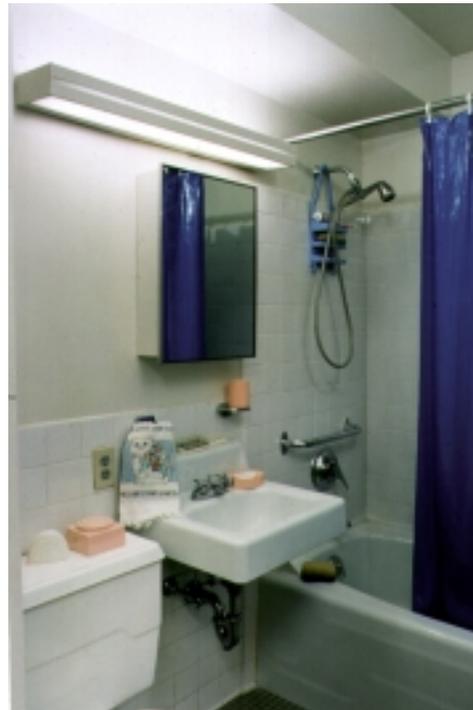
Bathroom, showing new lighting (type RE')

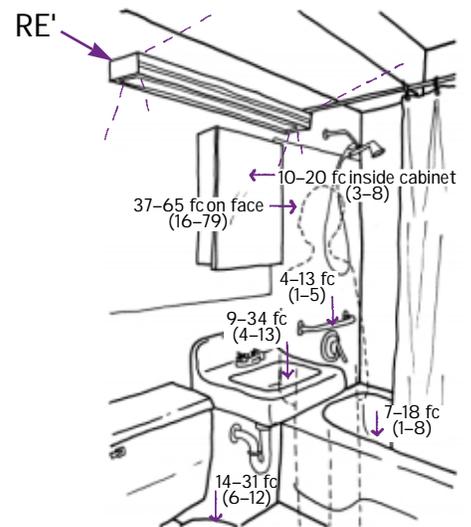
Perspective of bathroom, new lighting conditions (previous values shown in parentheses)

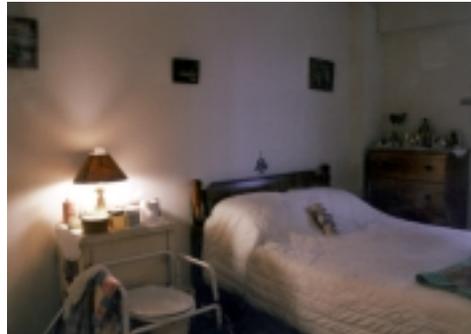
Bedroom, previous lighting conditions

Previous conditions Typical lighting consisted of one or two portable table or floor lamps, furnished by the residents and fitted with 60- to 100-W A-lamps. Illuminances were low in the main part of the bedrooms and in the closets (see ranges on illustration below).

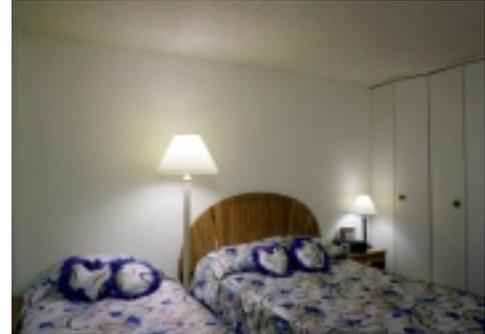
Bedroom, new lighting conditions (type RG')

illuminances in the bedrooms and in the closets when used at full light output. The floor lamp (type RG') provided somewhat less light in the bedroom and in the closet (see ranges on illustration at left).

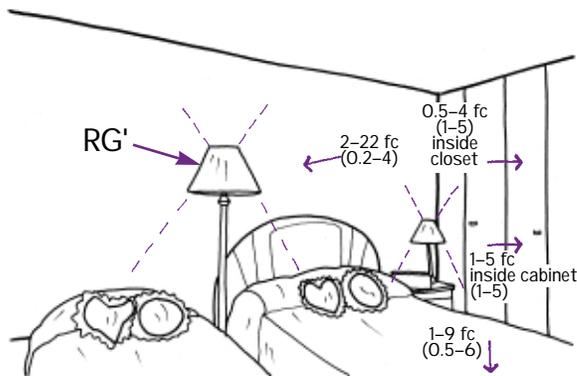
Perspective of bedroom (previous values shown in parentheses)

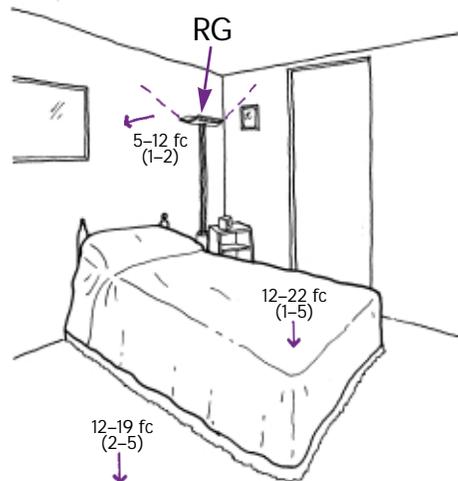
Perspective of bedroom (previous values shown in parentheses)

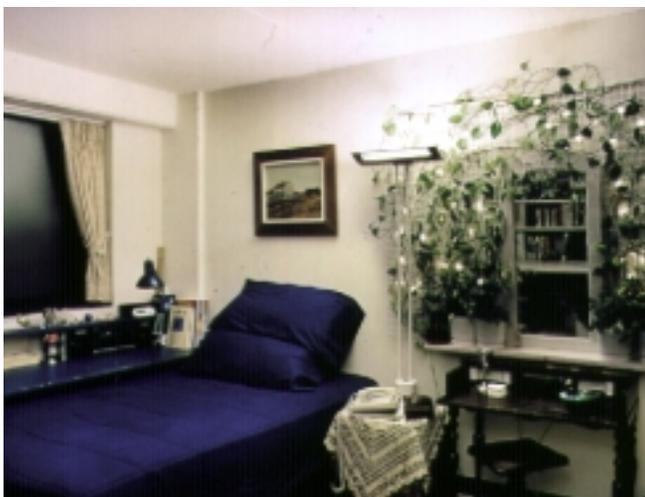
Bedroom, new lighting conditions (type RG)

New conditions Both retrofit luminaires were chosen to provide more light, widely distributed in the bedrooms, to minimize glare. The CFL torchiere (type RG) increased

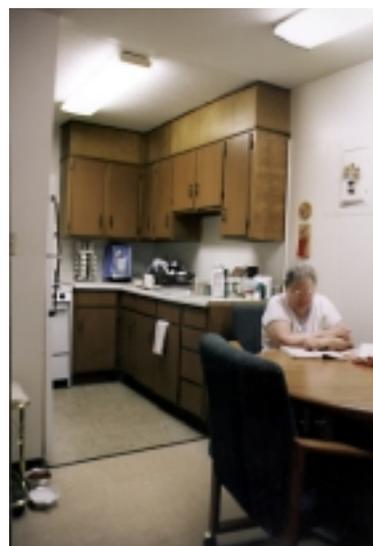
Kitchen, previous lighting conditions

Previous conditions A central ceiling-mounted wraparound fluorescent luminaire provided low illuminances on the working surfaces in a typical kitchen.

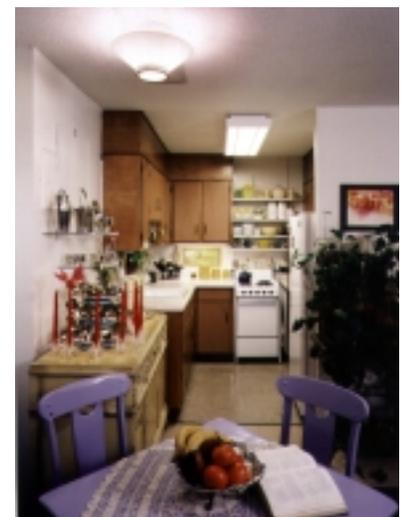
Kitchen, new lighting conditions (types RD and RB)

New conditions Narrow-profile undercabinet lighting is a key feature of

the retrofitted lighting. It provides light on the countertops without causing glare. The luminaire (type RC) is mounted at the front edge of the cabi-

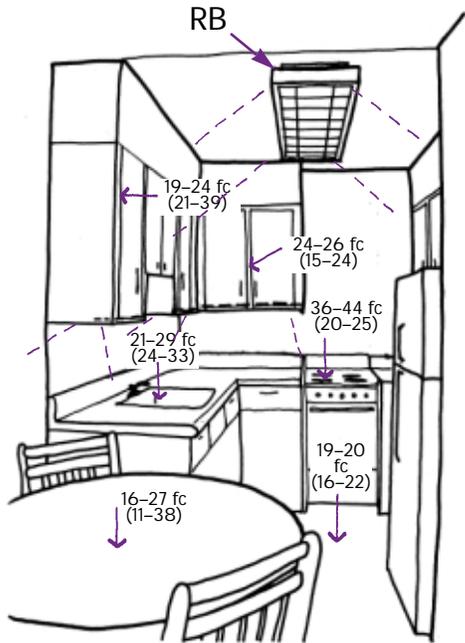
Perspective of kitchen (previous values shown in parentheses)

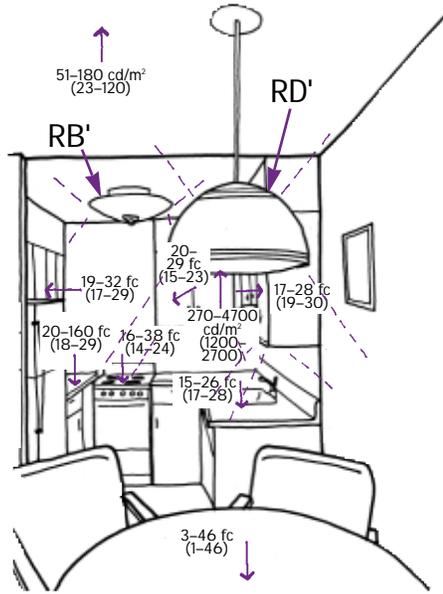
Perspective of kitchen (previous values shown in parentheses)

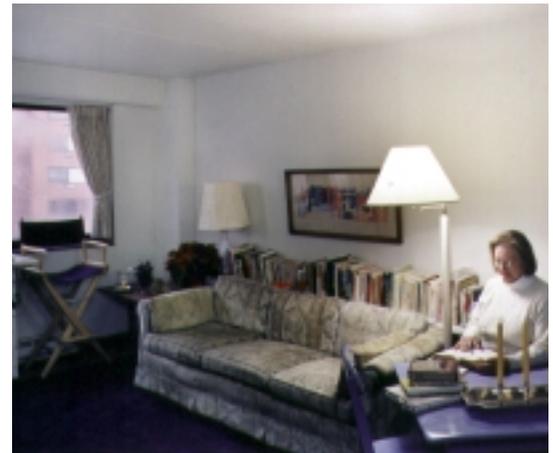
Living/dining room, new lighting conditions (type RF)

faulty ballast, produced poor illuminances, and was poorly received by residents. The pendant luminaire (type RD') performed well, and together with the CFL table lamp near the sofa (type RF'), produced more light on the floor, walls, and sofa. This retrofitted pendant luminaire (type RD') is much less bright than the previous wraparound luminaire. The performance of the three-way floor lamp (type RF) is similar to that of the CFL table lamp on the floor and walls, but it puts a much higher illuminance on the sofa.

Previous conditions These areas were lighted by a ceiling-mounted wraparound fluorescent luminaire over the dining area, as well as by the residents' own incandescent table lamps. The previous luminaire over the table was perceived as too bright (see ranges on illustration at right).

New conditions The retrofitted luminaires were chosen to be more residential in appearance, provide more light around the room, and reduce luminaire brightness. Unfortunately, the close-to-ceiling CFL luminaire (type RD) over the table had a

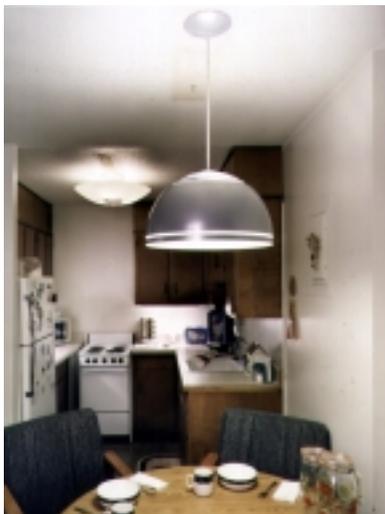
Kitchen, new lighting conditions (types RB' and RD')

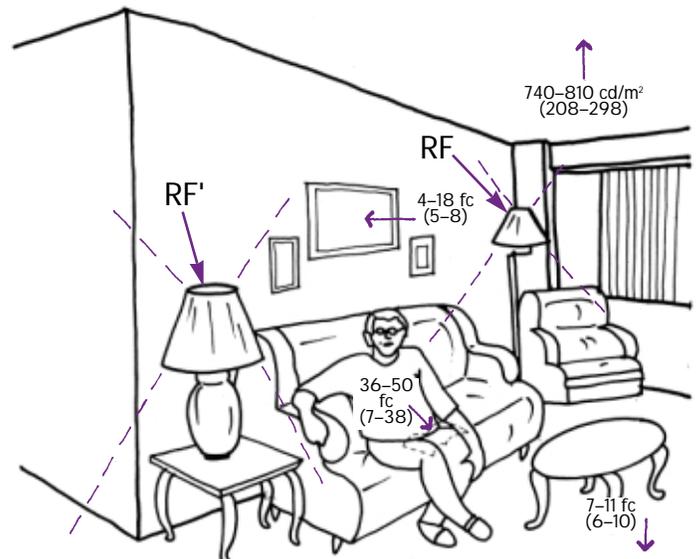
Perspective of living/dining room (previous values shown in parentheses) (types RF and RF')
